**Robert S. Crain Highway
Interchange at MD3
(MD3A)**

**UPPER PATUXENT RIVER WATERSHED RESTORATION ACTION STRATEGY (WRAS)
FORM 1 -- Catchment Information**

Site Name: US301/MD3 and Medford Road Address: Medford Road

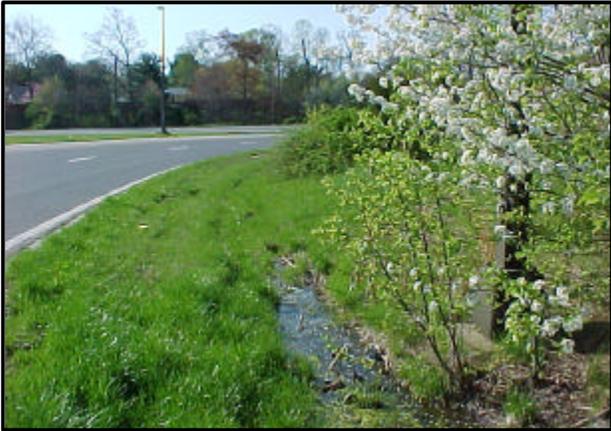
- No. 607 Description: looking west along entrance ramp to southbound lane
- No. _____ Description: _____
